Australian Transport Safety Bureau

Rail Technical Society of Australasia

9 July 2008

Major level crossing collision at Ban Ban Springs, Northern Territory

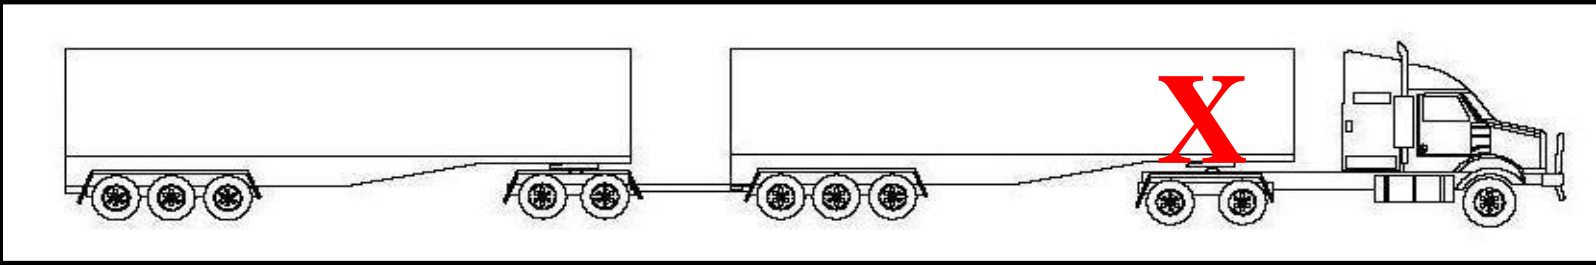
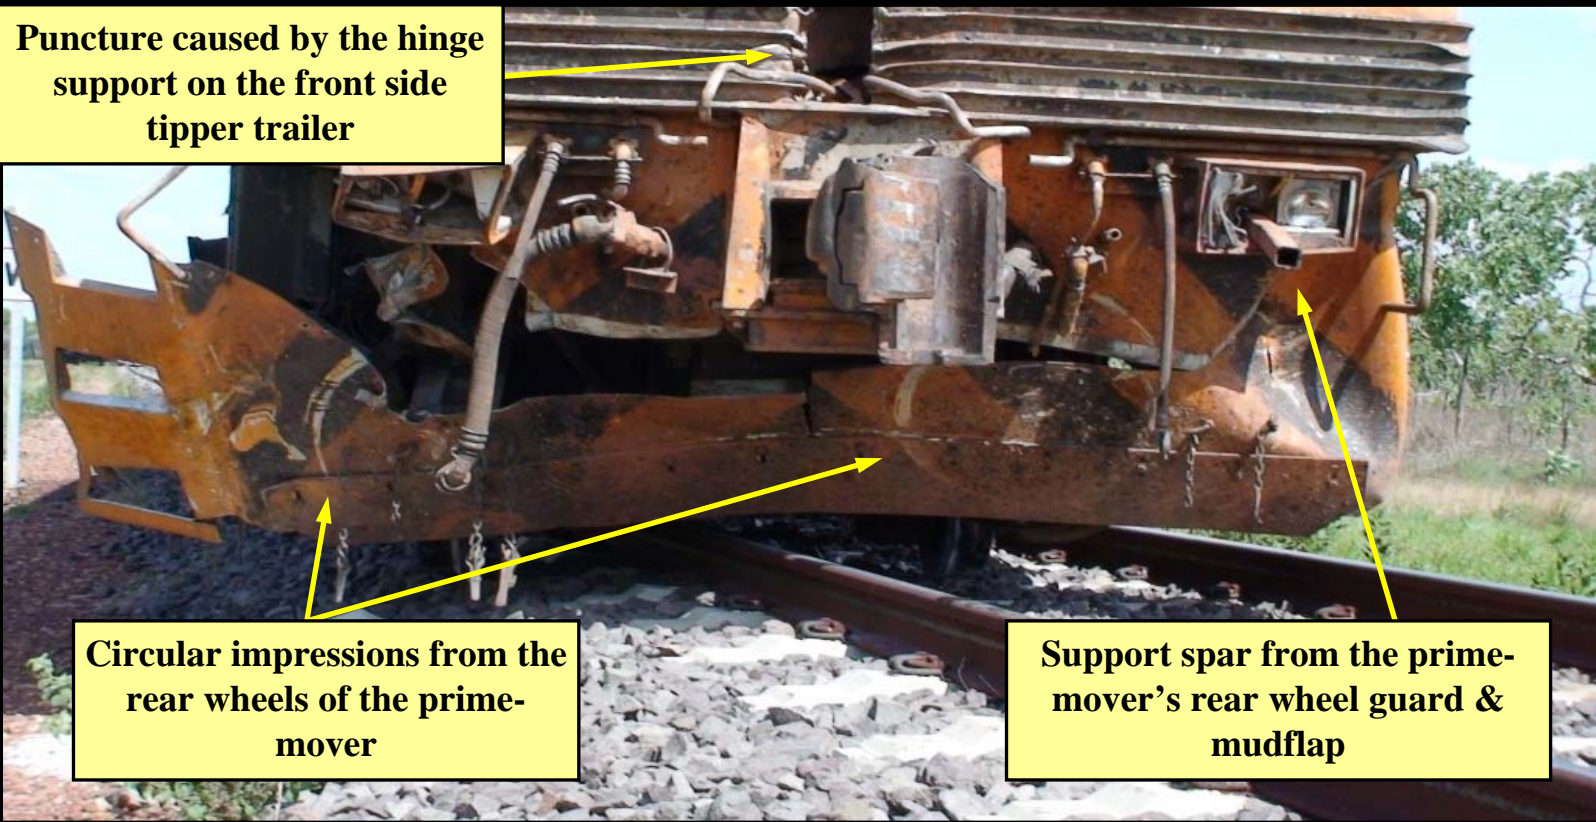
Point of impact

Puncture caused by the hinge support on the front side tipper trailer

Circular impressions from the rear wheels of the prime-mover

Support spar from the prime-mover's rear wheel guard & mudflap
