# RTSA SA CHAPTER NEWSLETTER

September 2011 Edition

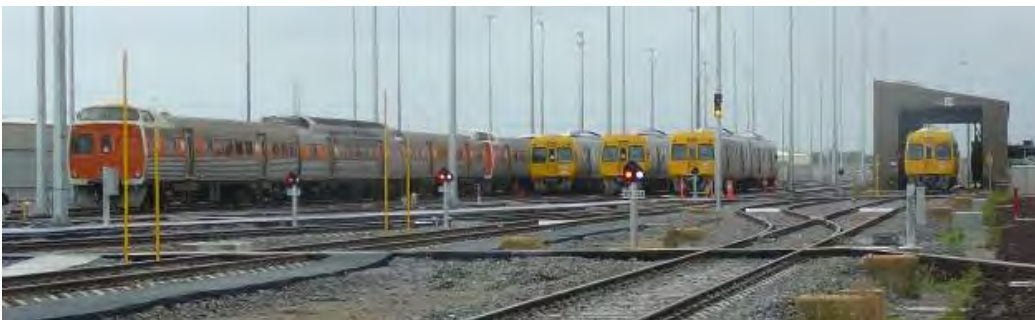
Bombardier will be hosting the visit where members will have the opportunity to see all aspects of a working maintenance depot and enjoy a BBQ on completion.

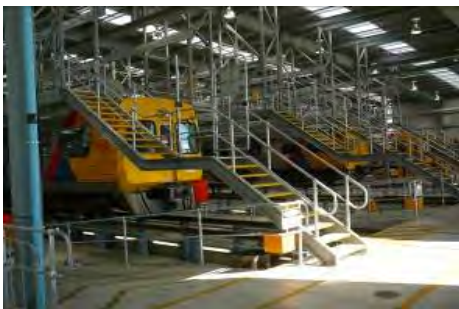
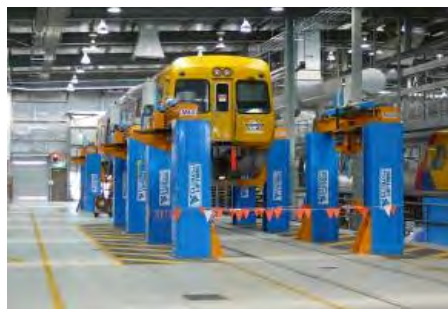
Please note that sturdy fully enclosed footwear and a 'HI VIS' safety vest must be worn during the inspection of facilities.

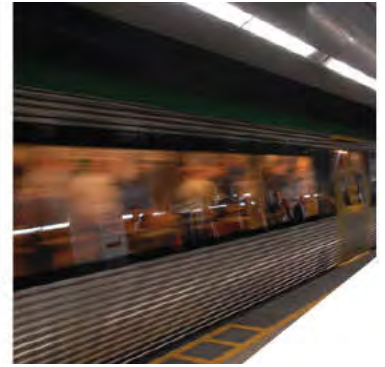
## Chair's Chatter: What value do you put on 'pride'?

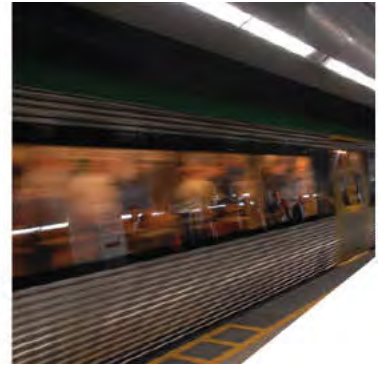
## Greens want ACT to go hard on light rail

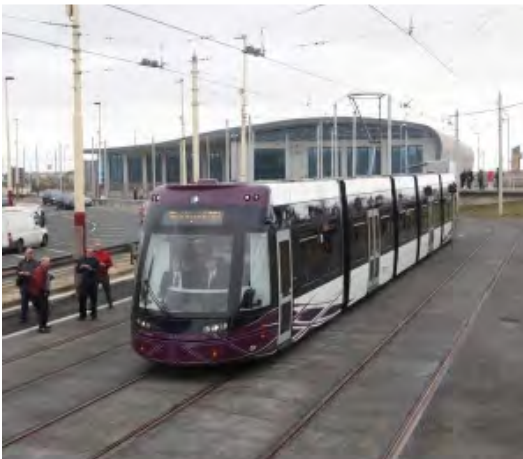
*Flexity 2 No. 001 making its first run with passengers on the Blackpool sea front. In the background is the new Starr Gate depot.*

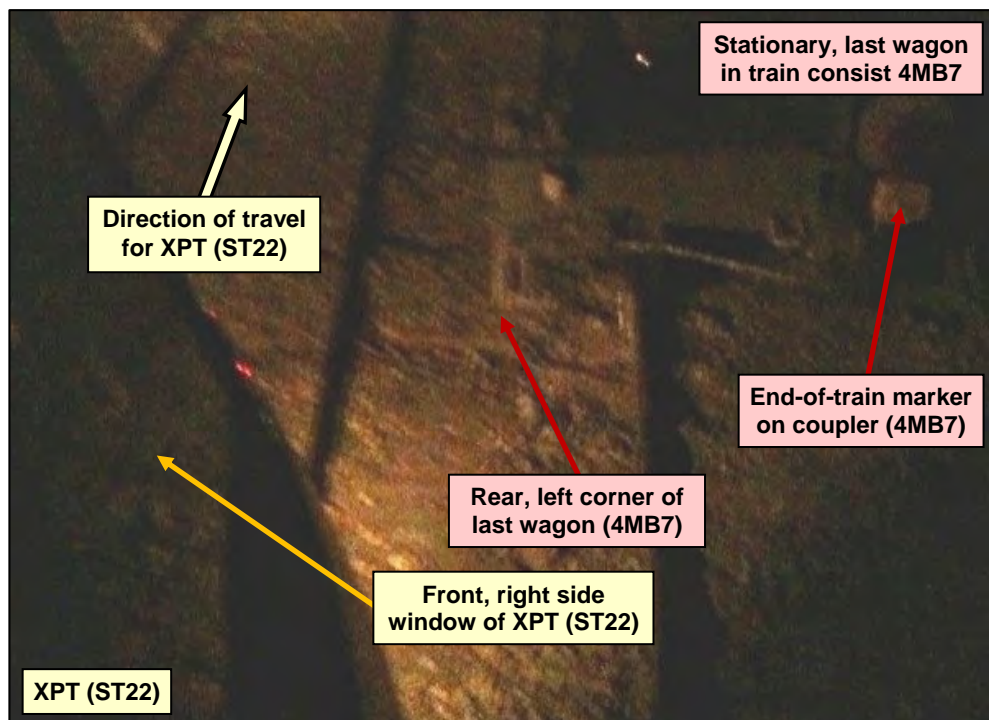
Copyright – Driver of ST22 ©

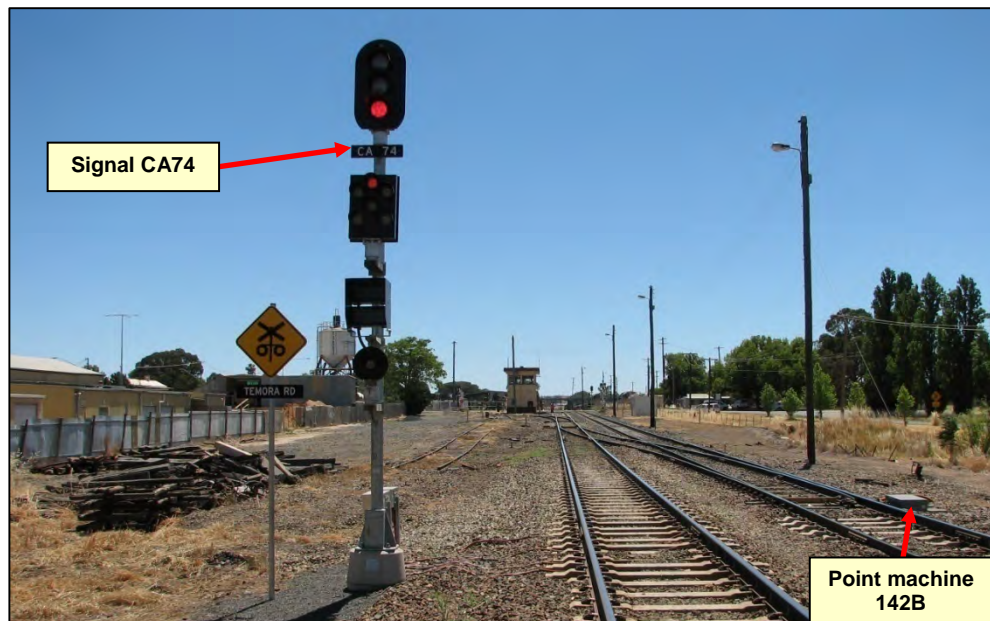
2. Interlocking Plant, Microlok system (Figure 6): Microlok is a proprietary microprocessor-based logic controller specifically designed for railway fail-safe<sup>6</sup> applications. The system provides all the necessary interlocking functions between points, signals and conflicting train routes. The system processes all the various field inputs and drives the outputs interfacing with designated field

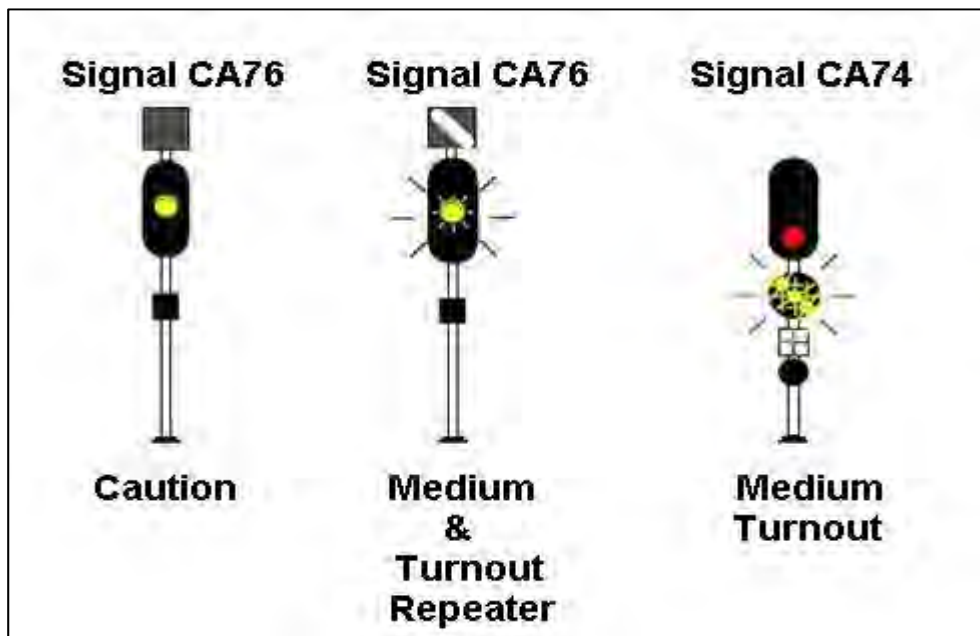
Note: The radial lines on the Medium and Medium Turnout indications imply that the lights are pulsating indications.

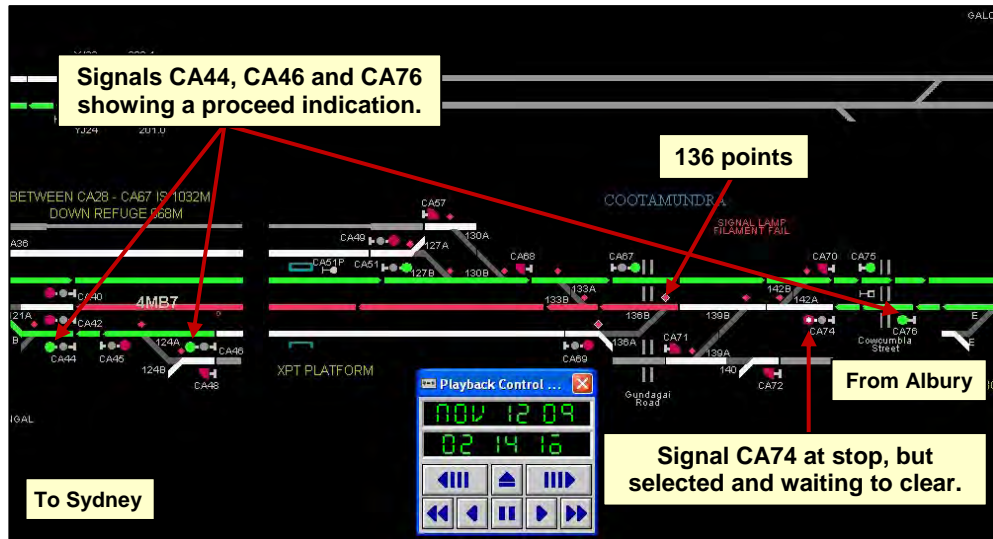
Copyright – Australian Rail Track Corporation ©

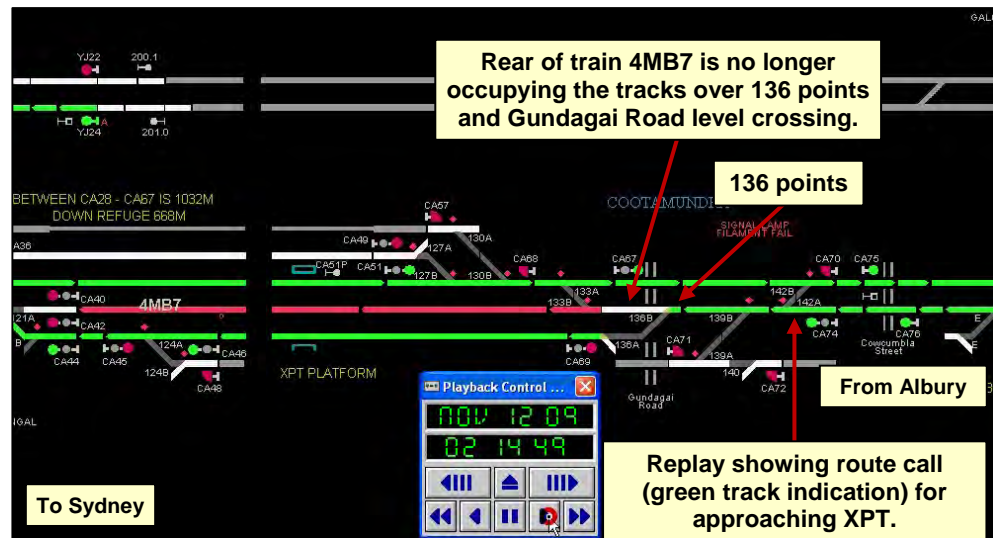
Copyright – Australian Rail Track Corporation ©

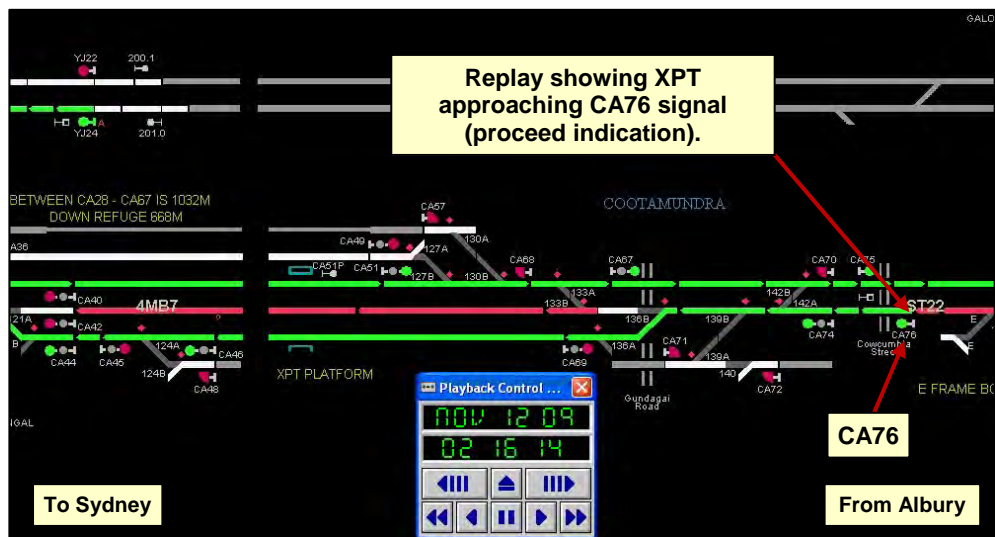
Copyright – Australian Rail Track Corporation ©

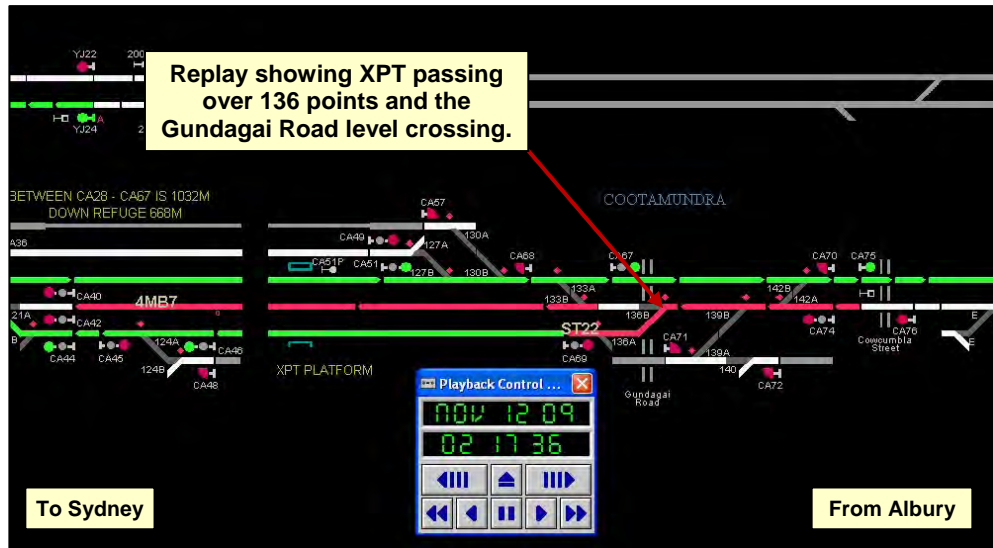
Copyright – Australian Rail Track Corporation ©

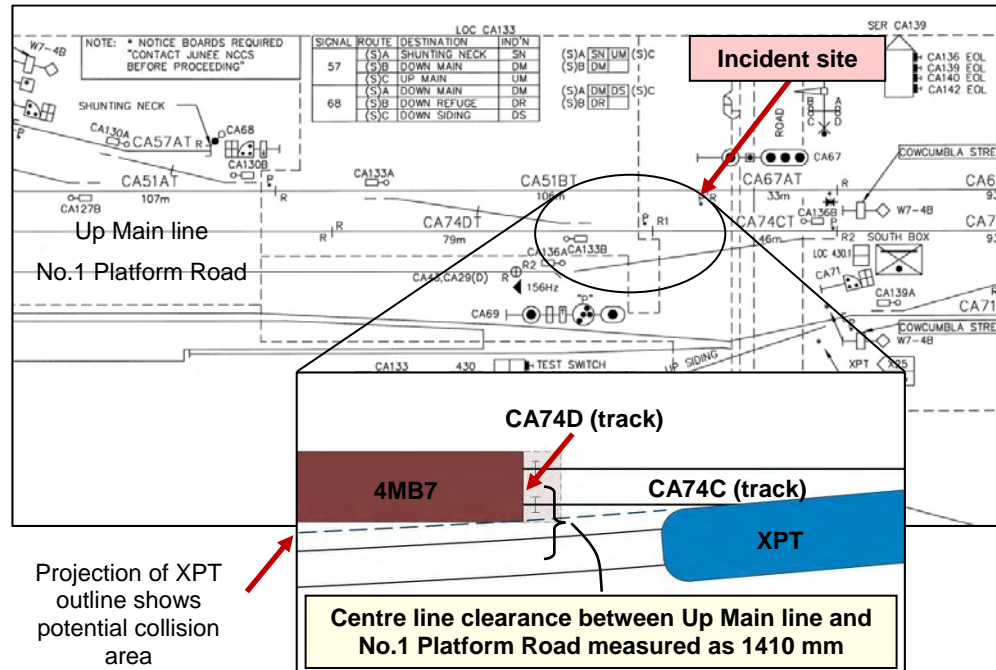
Later that morning, ARTC signal engineers used the Phoenix replay file to examine the events leading up to the incident. This was followed by a review of the signalling control tables which established that the insulated joint interface between CA74D track and CA74C track (Figure 20 and Figure 21) was designed as the clearance point for a train movement from CA74 to CA42 signal. This meant that when the wheels of 4MB7 had passed the clearance point (the insulated joint between CA74D and CA42C track circuits) the signalling system allowed the alternative route, namely, CA74 to CA46 signal to become available for the XPT.

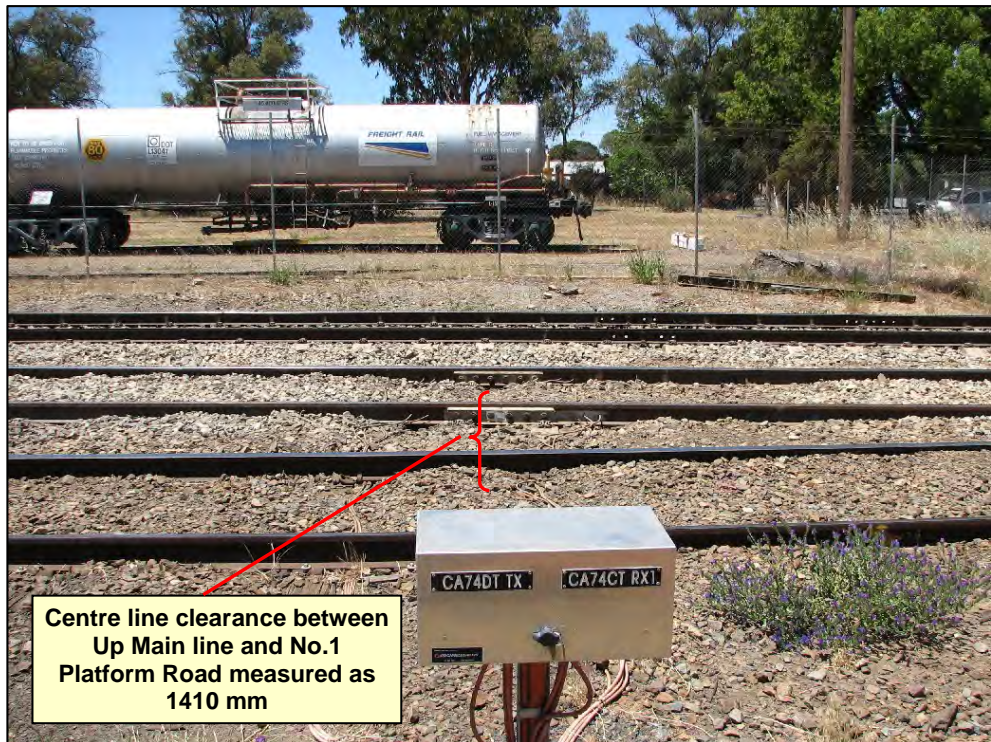
It was therefore concluded that the observations by the driver of the XPT were correct, in that the rear of 4MB7 was obstructing the path of the XPT even though signal CA74 was showing a proceed indication.
